**INTEGRATED PROPULSION CONTROL SYSTEM (IPCS)  
FINAL REPORT  
VOLUME III  
FLIGHT TEST REPORT**

**BOEING AEROSPACE COMPANY  
P.O. BOX 3999  
SEATTLE, WA. 98124**

**AUGUST 1976**

**TECHNICAL REPORT AFAPL-TR-76-61 VOLUME III  
FINAL REPORT FOR PERIOD 1 MARCH 1973 - 30 AUGUST 1976**

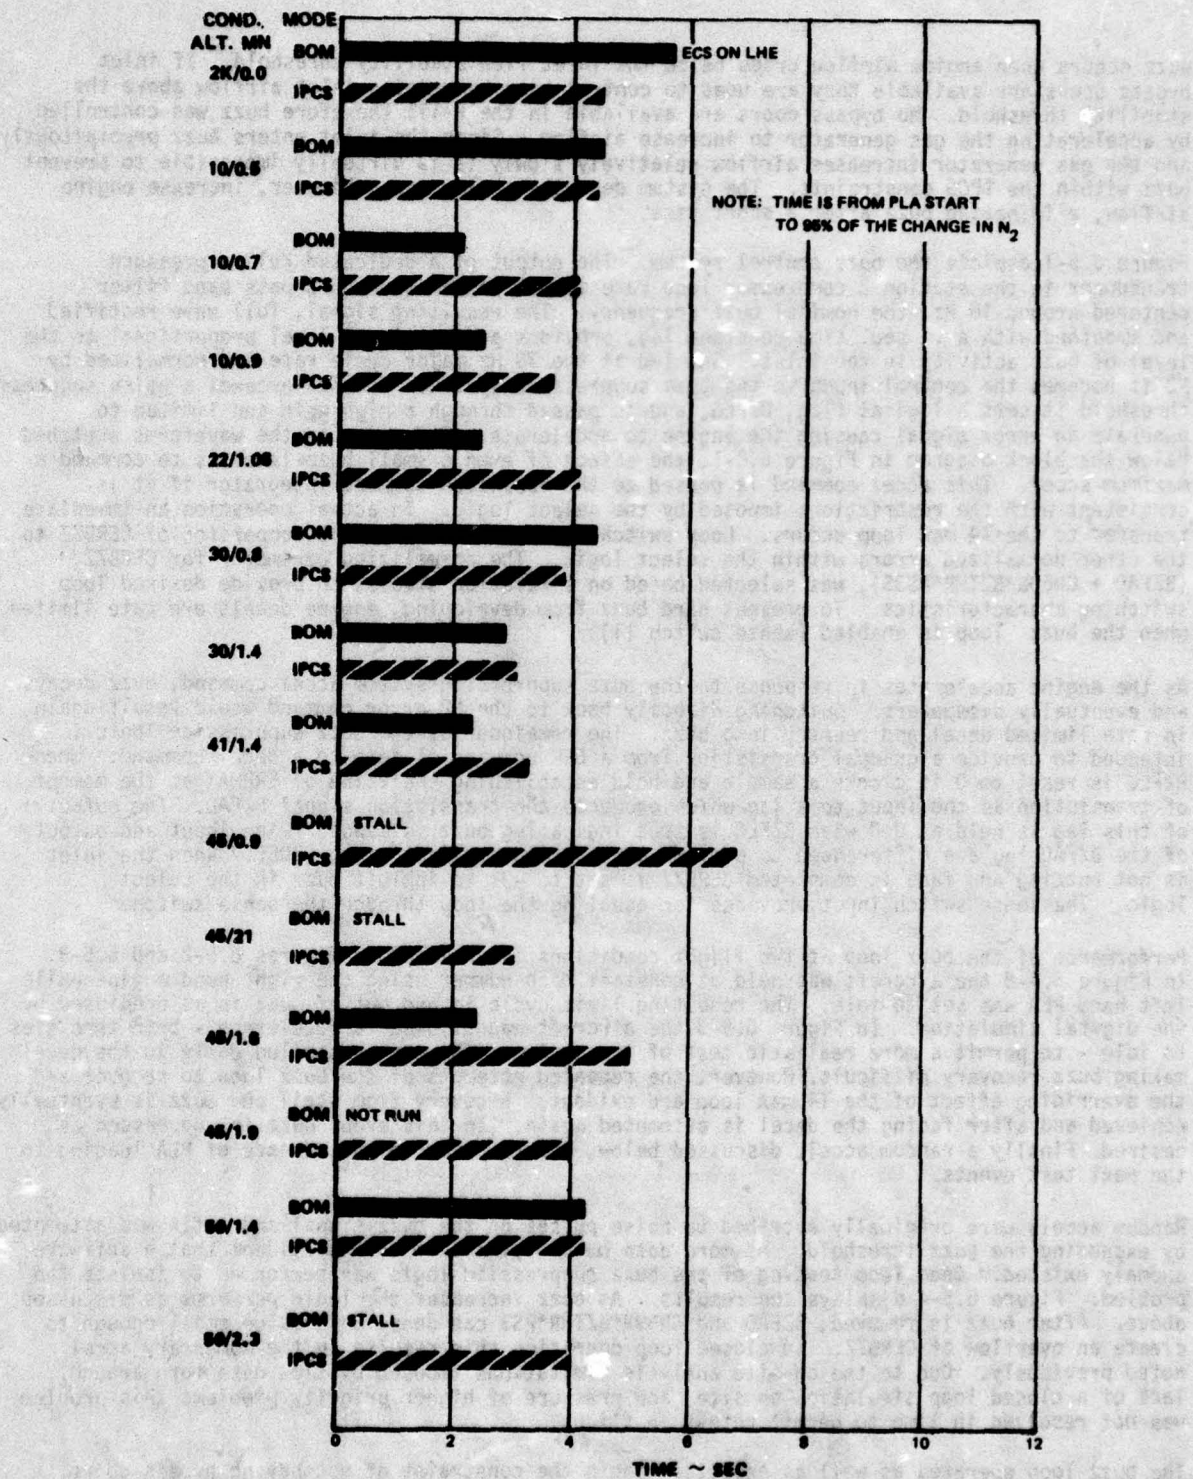
Figure 6.4-4 Decel Time Comparison Max - Idle

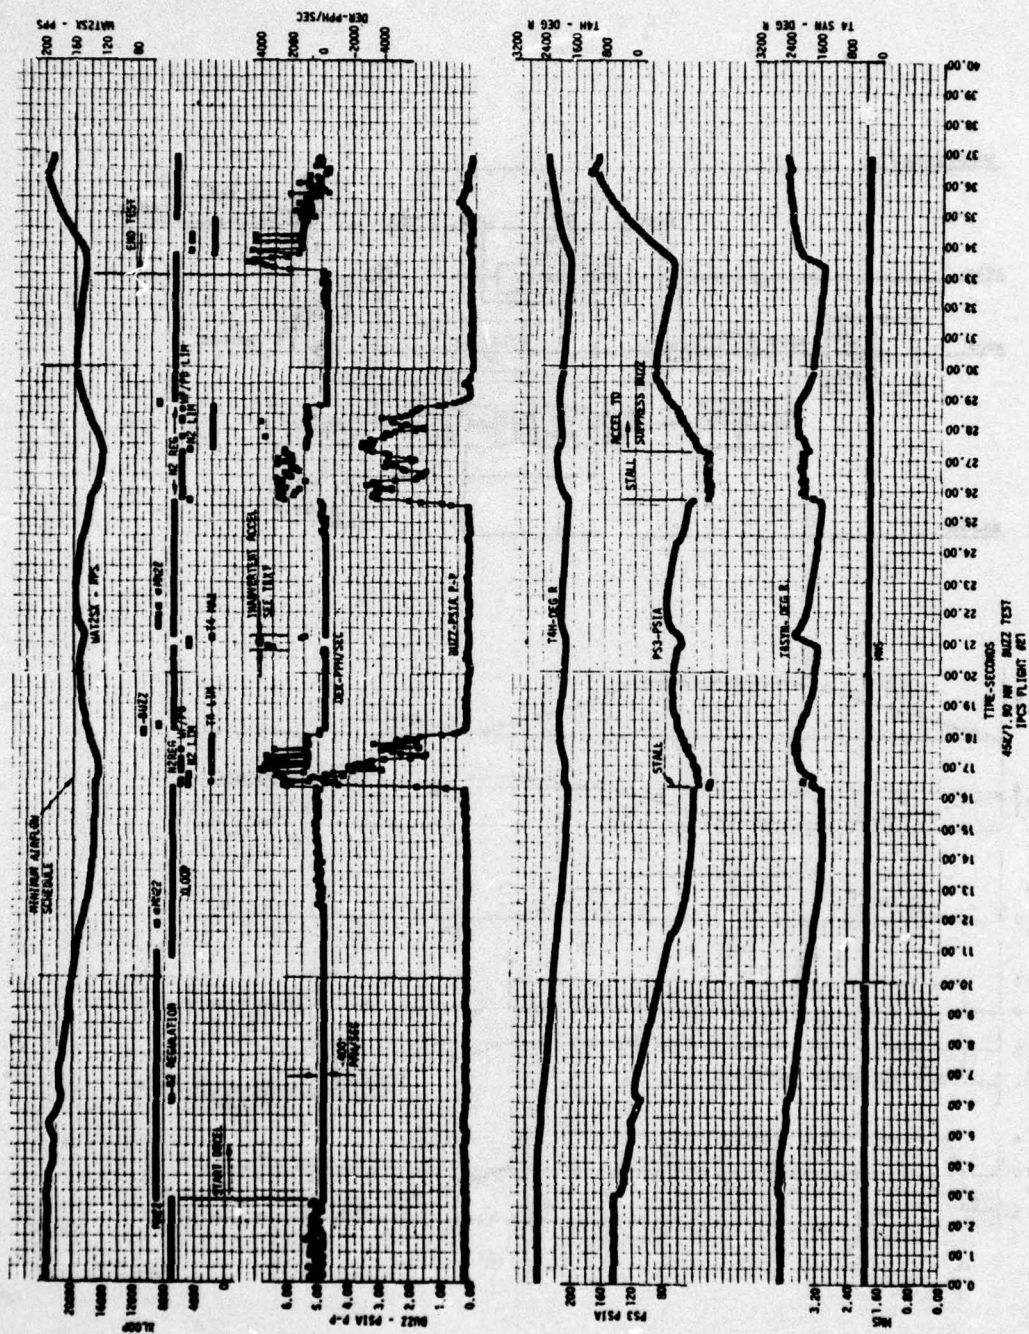
Figure 6.5-2 Mach 1.9 Buzz Loop Evaluation

The buzz loop operated as well as expected within the constraint of not having bypass doors. Engine airflow during deceleration was reduced roughly 30 PPS below the IPCS minimum airflow schedule as indicated in the figures. Buzz, when encountered, was suppressed -although slowly.

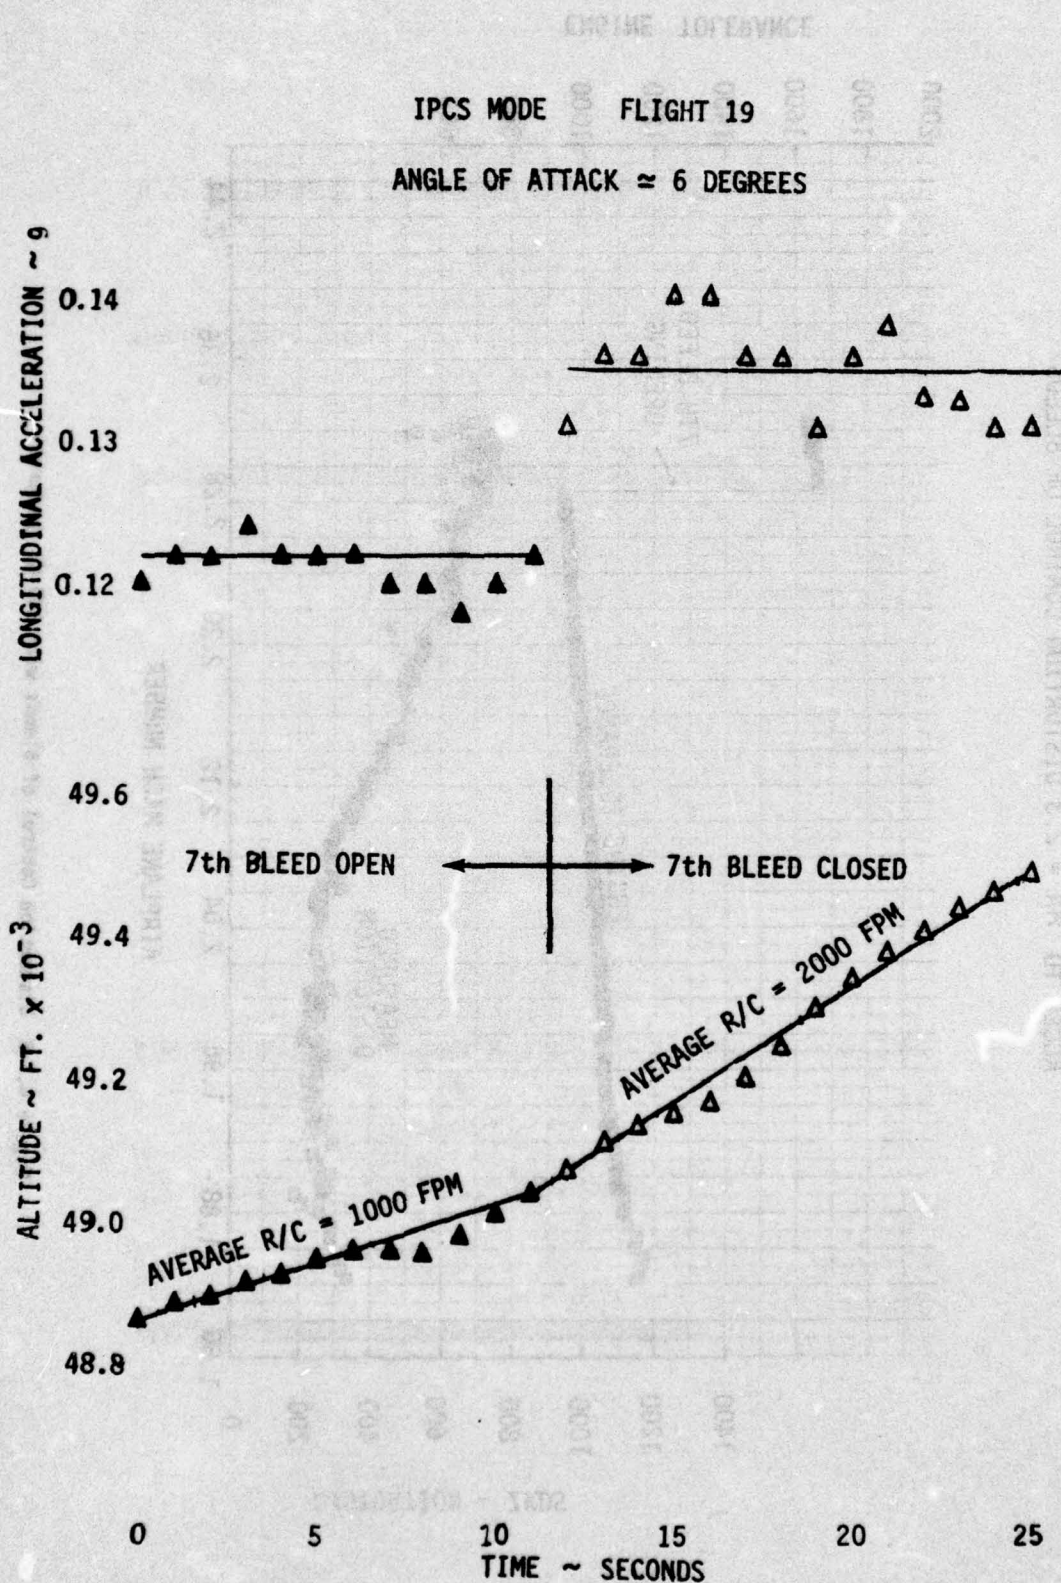
Figure 6.5-9 Effect of 7th Stage Bleed During 500 Knot Climb to Maximum Altitude

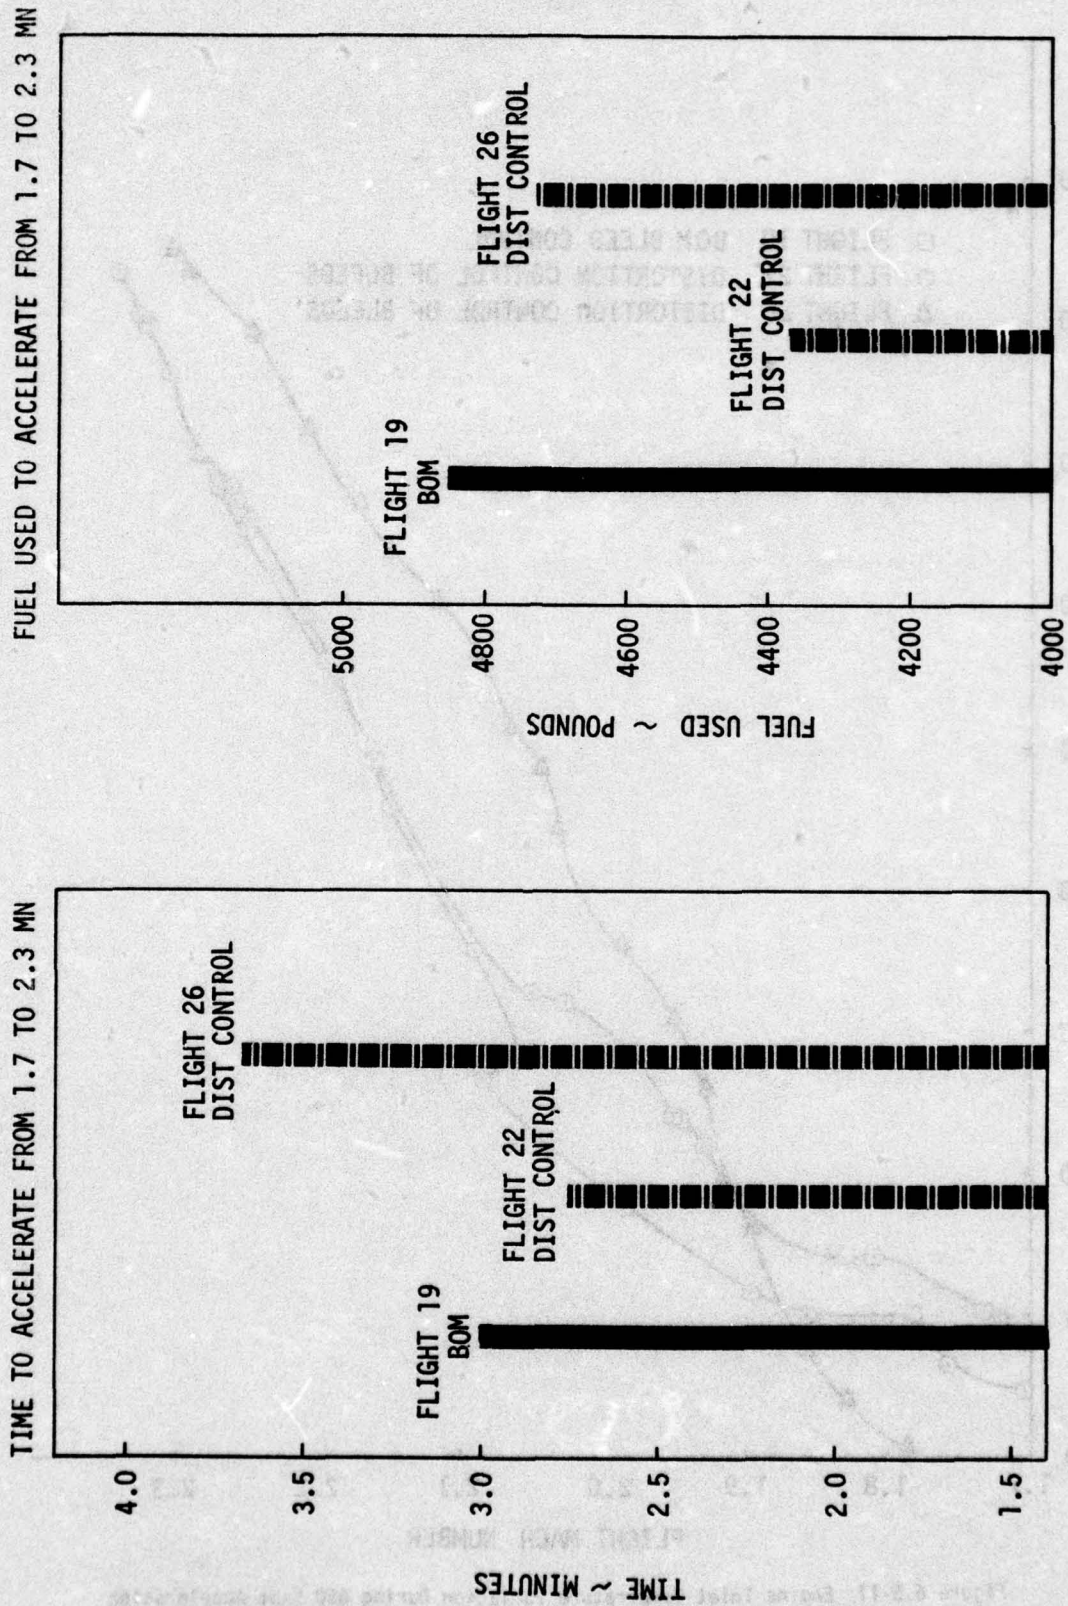
Figure 6.5-10 650 Knot Acceleration Comparison

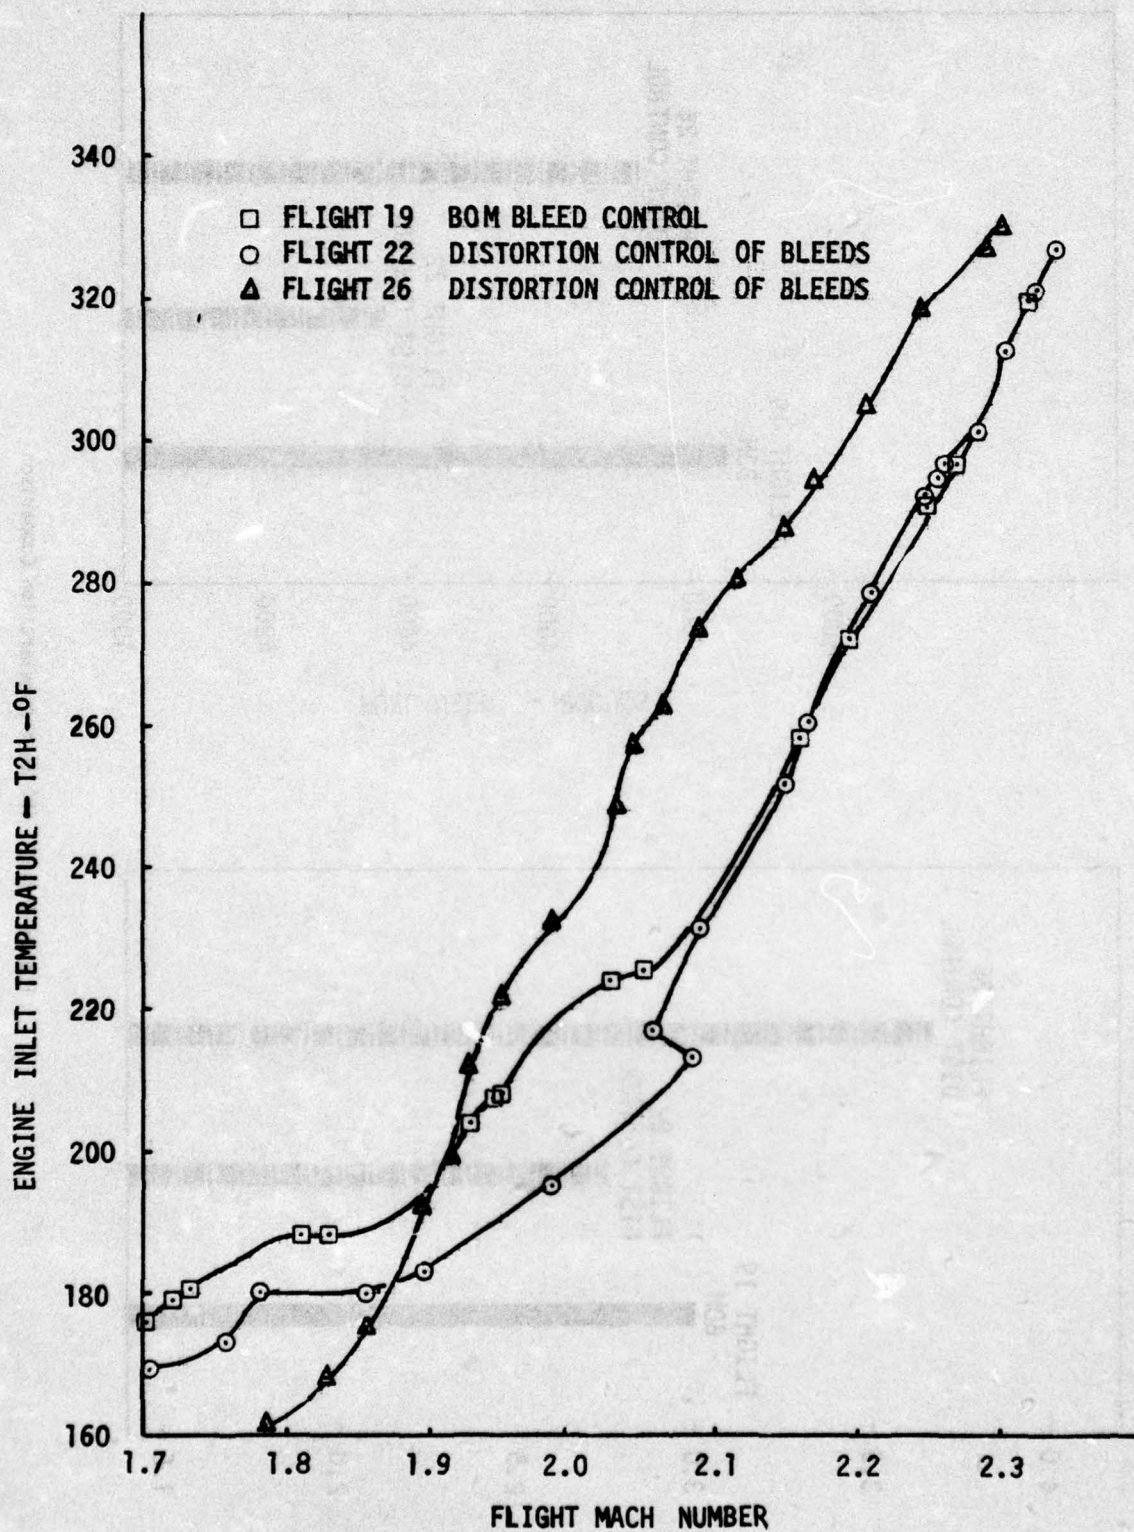
Figure 6.5-11 Engine Inlet Temperature Variation During 650 Knot Acceleration

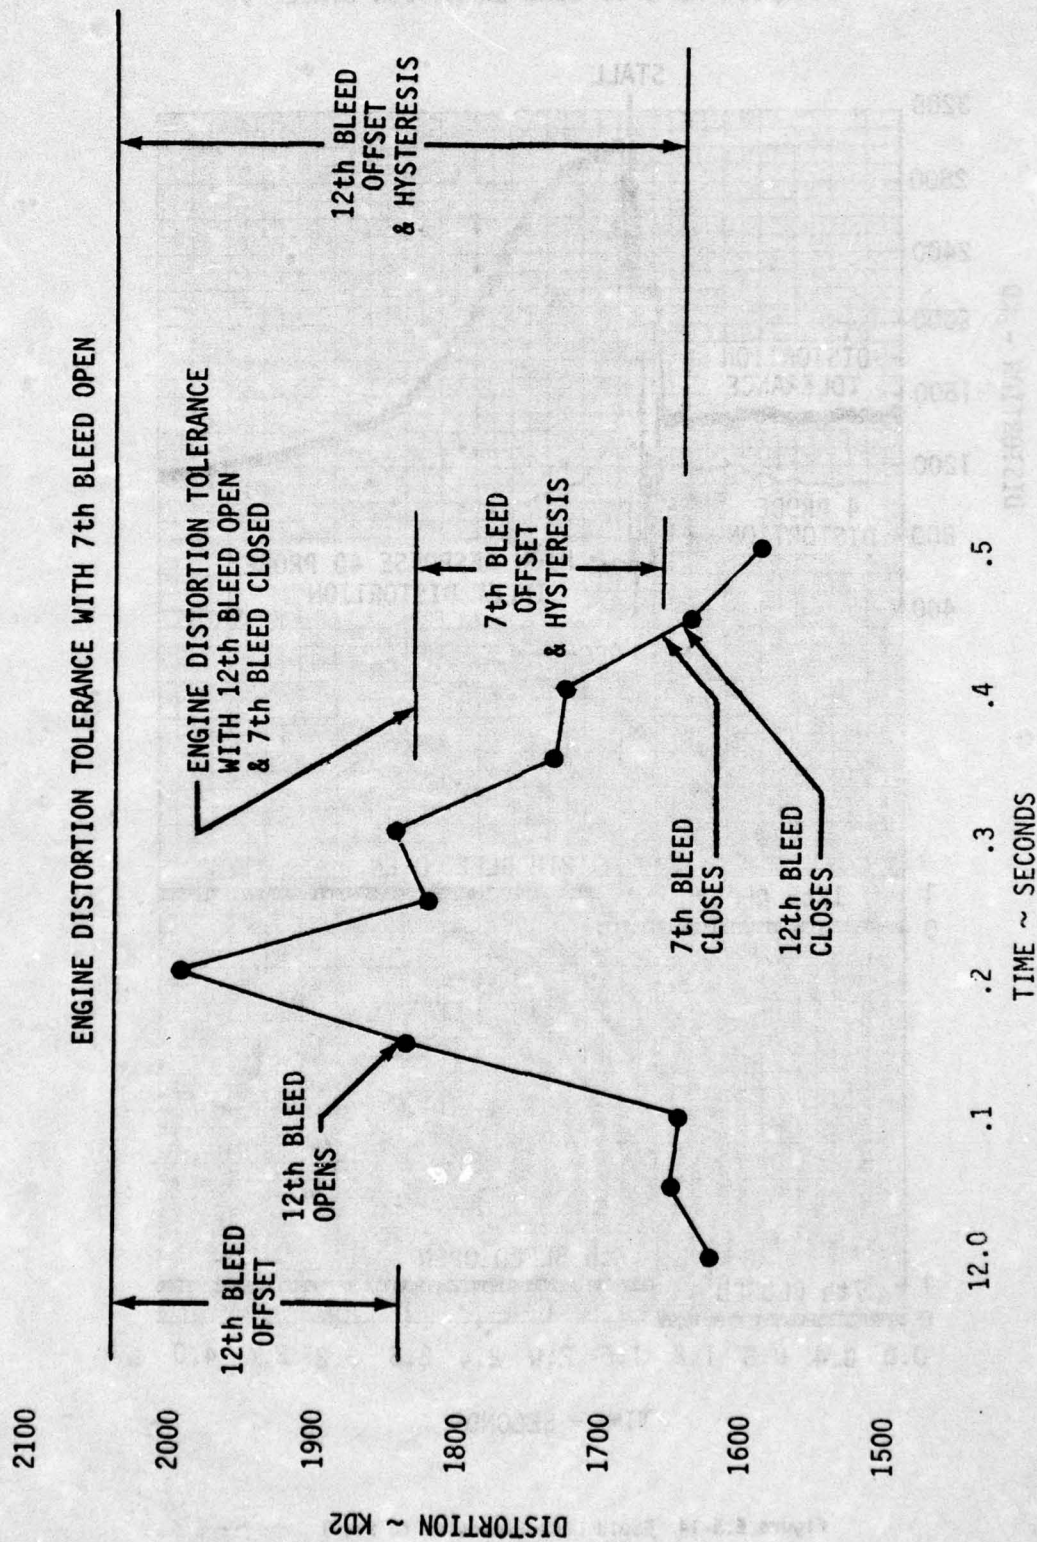
Figure 6.5-13 Bleed Cycling in Response to Distortion

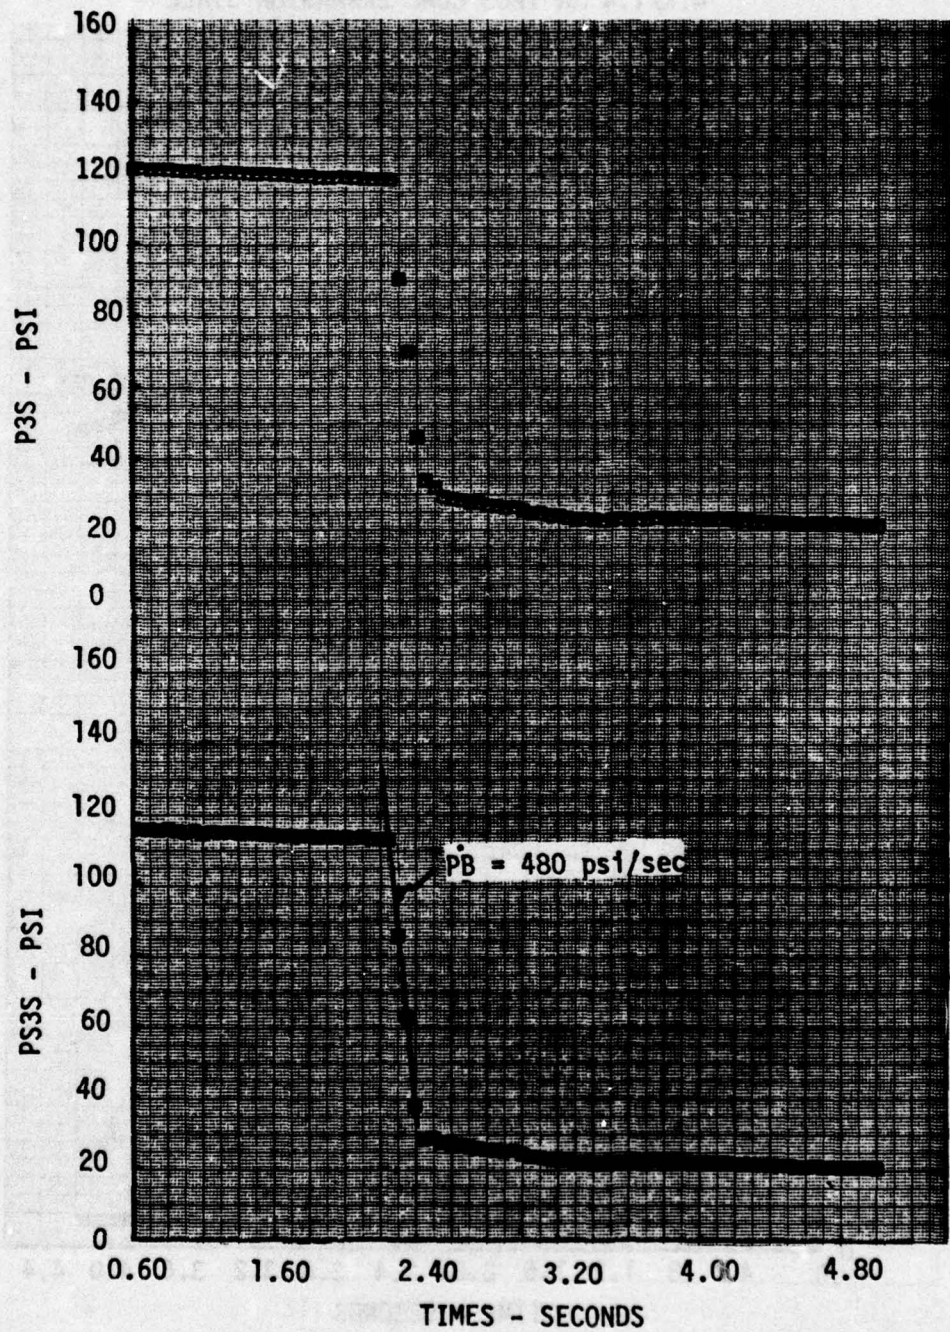
Figure 6.5-20 PS3S Decay Rate Following Stall

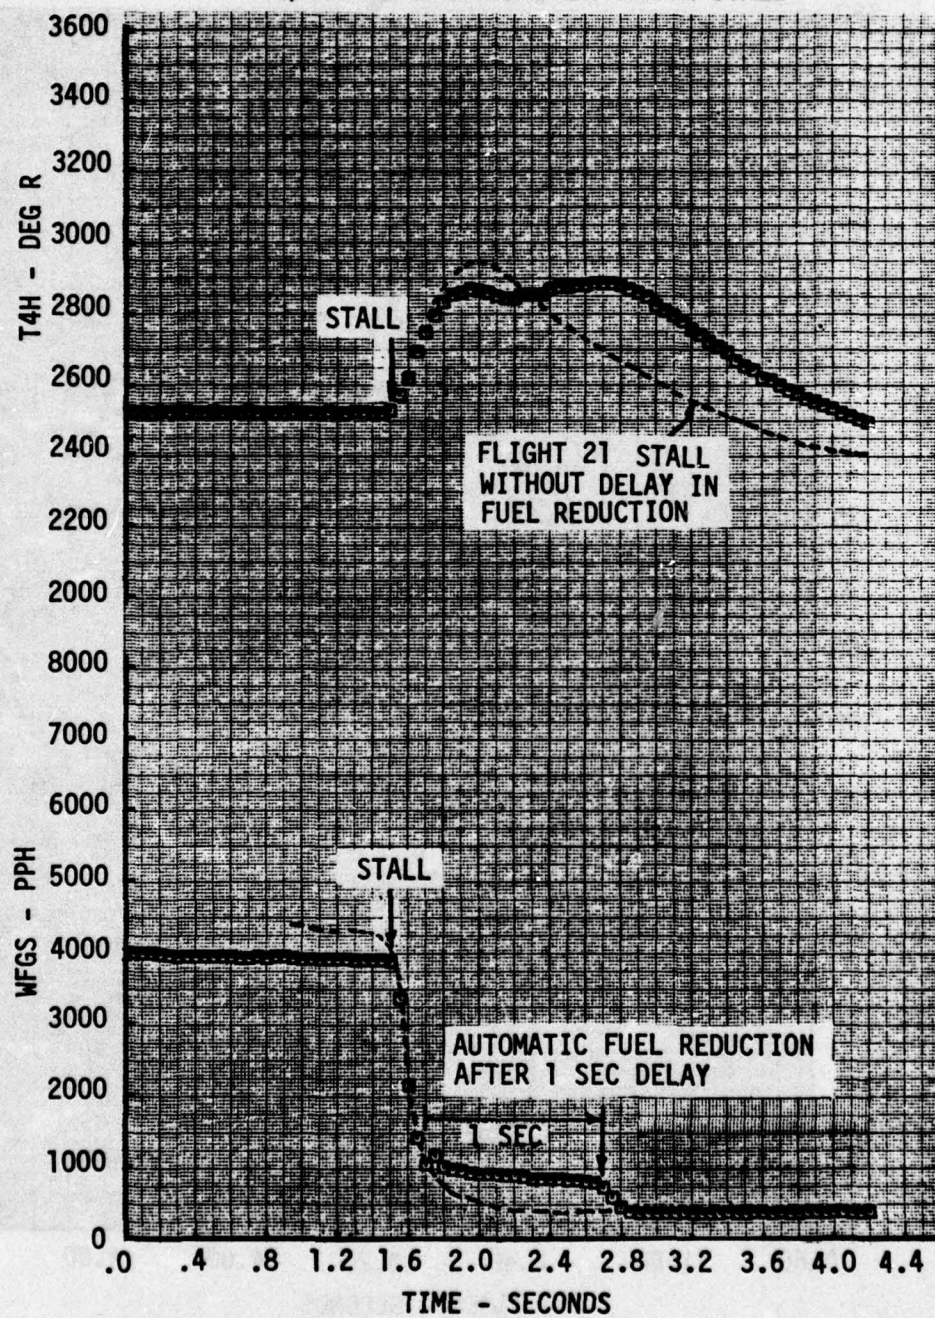
Figure 6.5-21 Stall Detection

Compressor stall was detected by measuring the rate of decay of burner pressure and comparing it to a reference schedule. Once stall was detected the engine PLA was set to idle and the bleeds opened. This feature was successfully demonstrated at a wide range of flight conditions. It was able to detect all but very low power stalls and it discriminated against normal Pb transients.

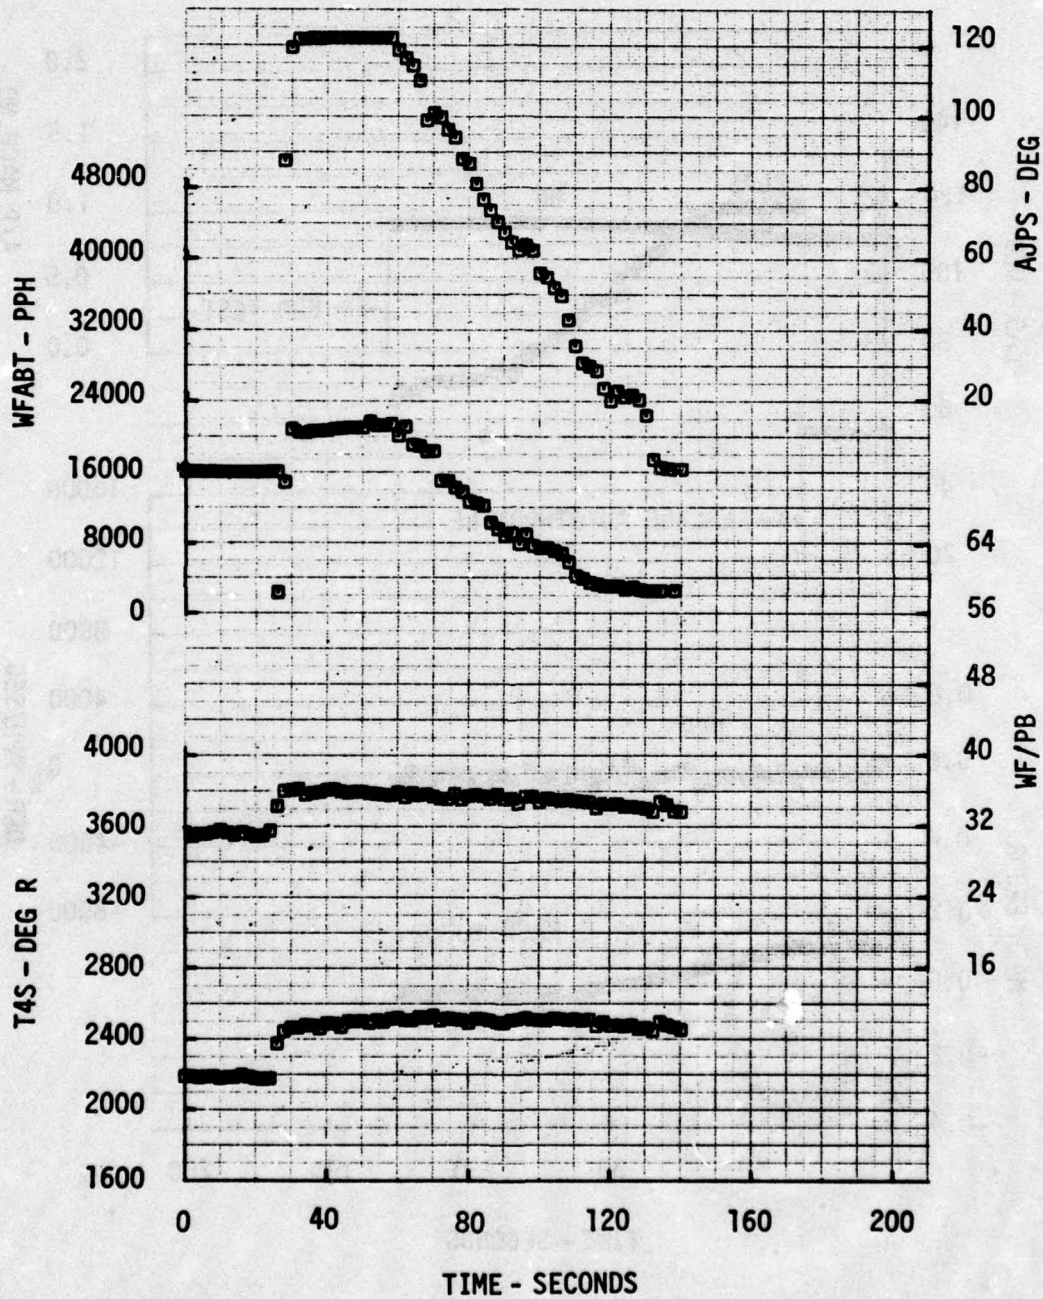
Figure 6.5-23b Autothrottle Performance

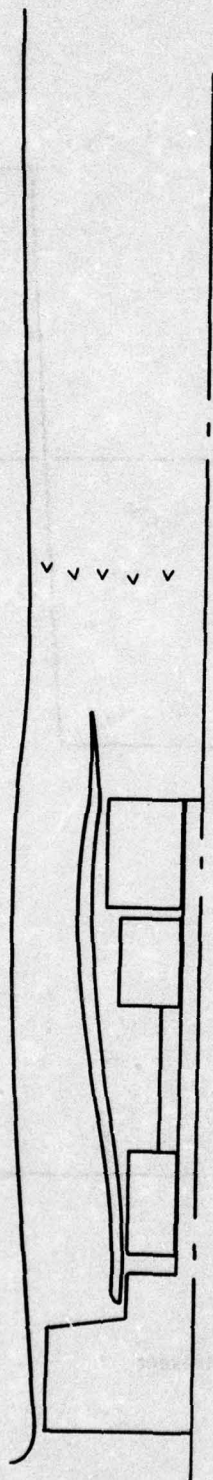
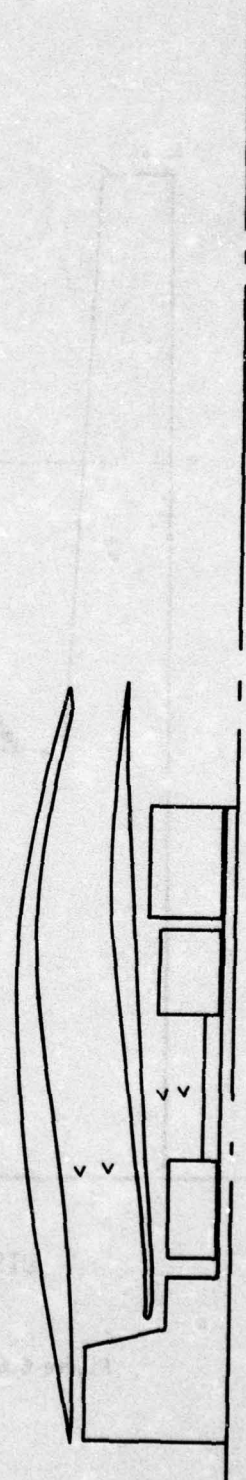
MIXED BURNING ENGINE

DUCT BURNING ENGINE

Figure 6.6-1 Afterburner Configurations

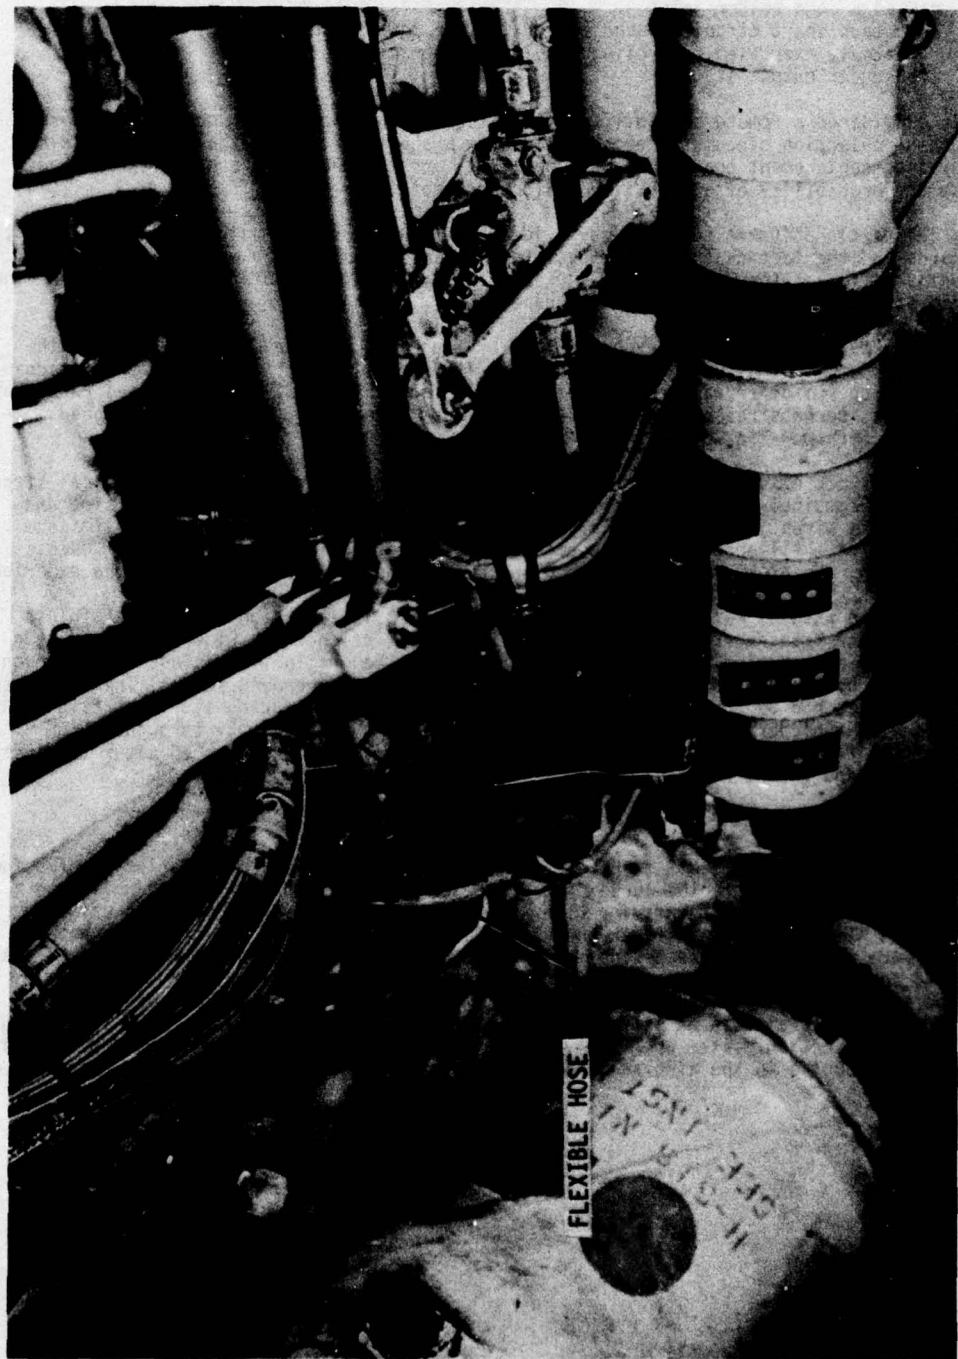
Figure 7.4-1 Parascientific Transducer Installation

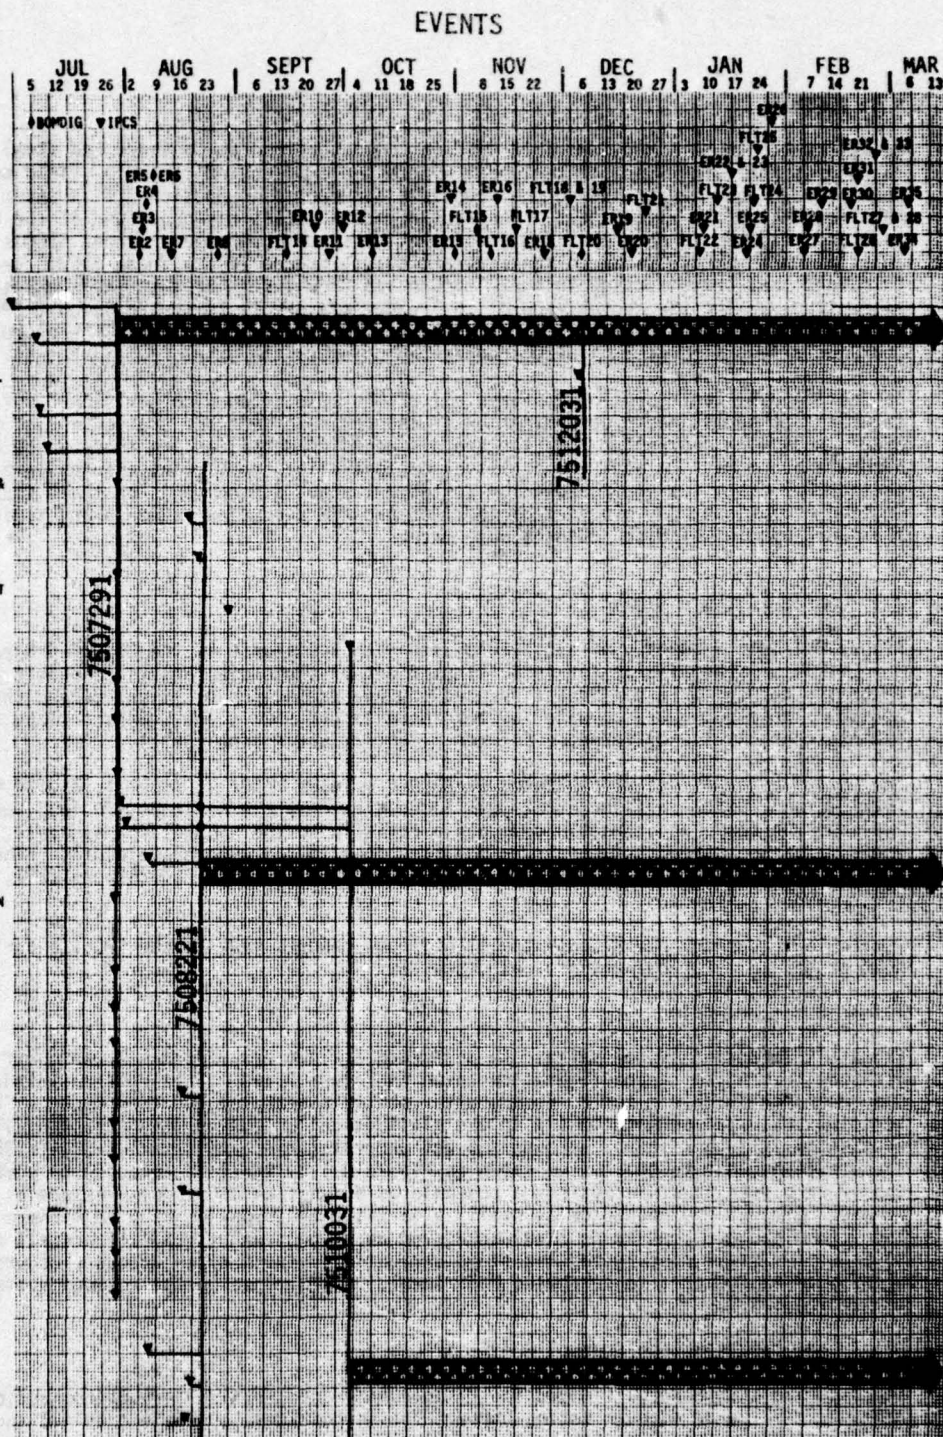
Figure 8.1-1 BOMDIG SFCO Summary

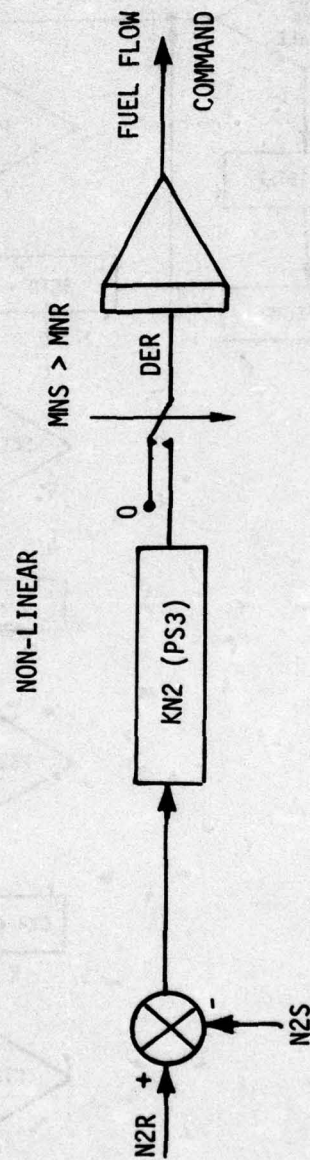
Figure 8.1-5b Non-Linear MN3 Control

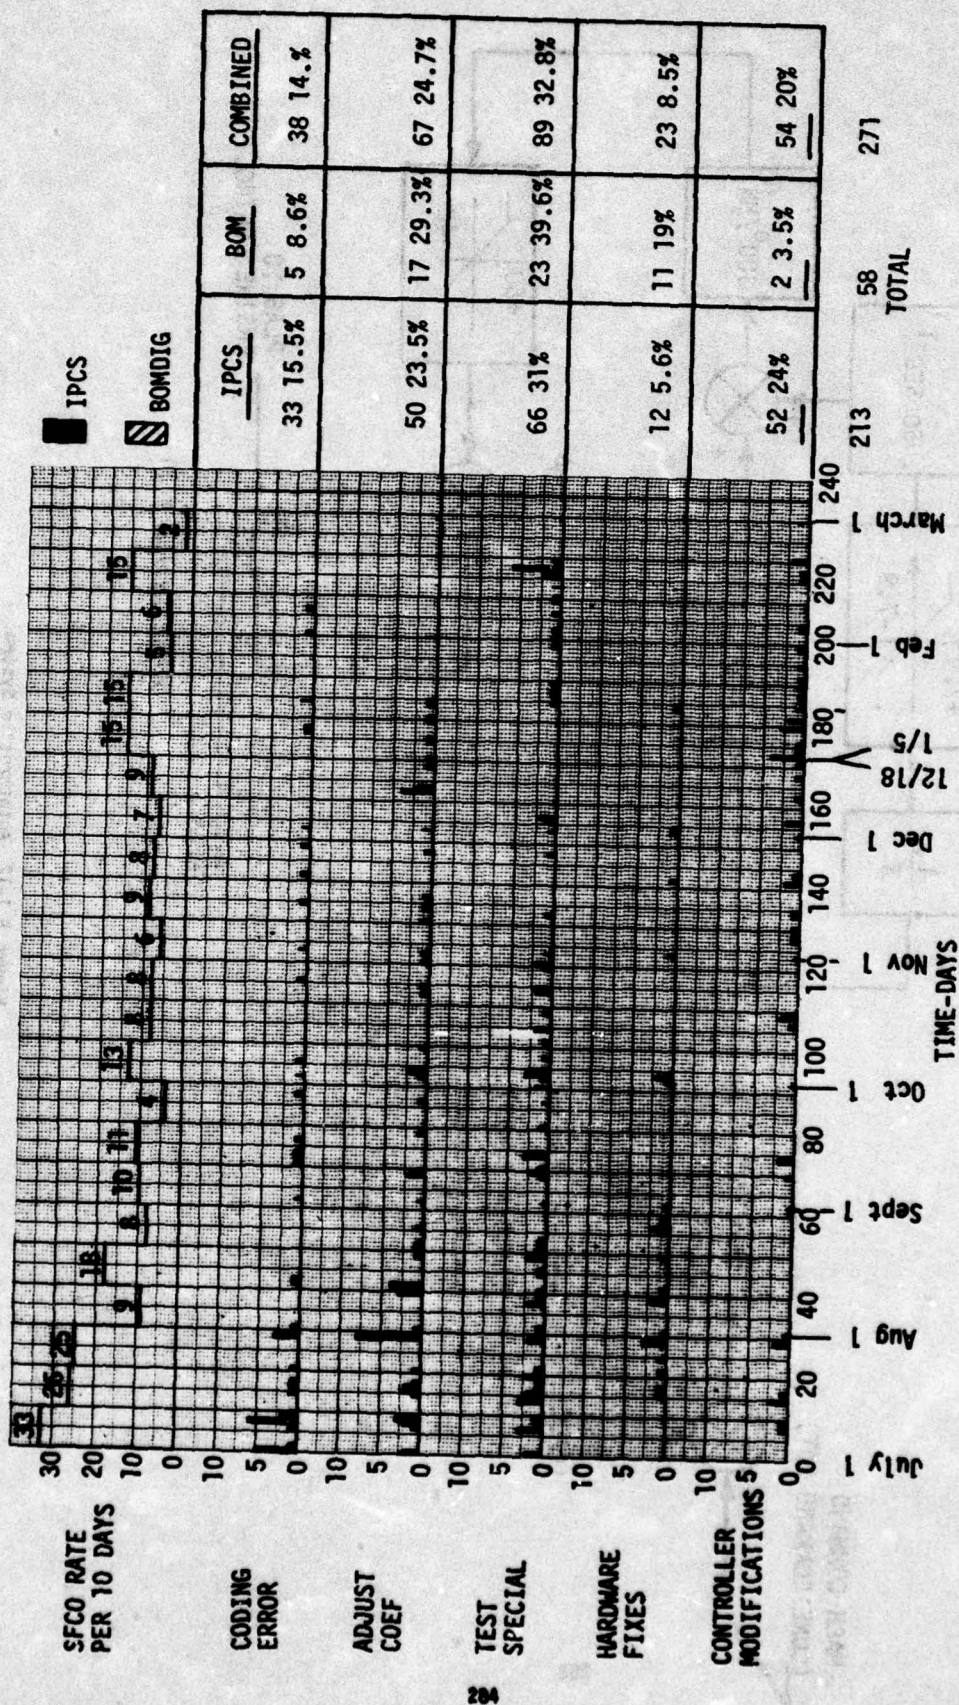
Figure 8.2-1 SFCO Summary - Revision C CPCEIs
